PAX RIVER HCAT ROD TESTING

Jeff Gribble / James Magno

July 2004 HCAT

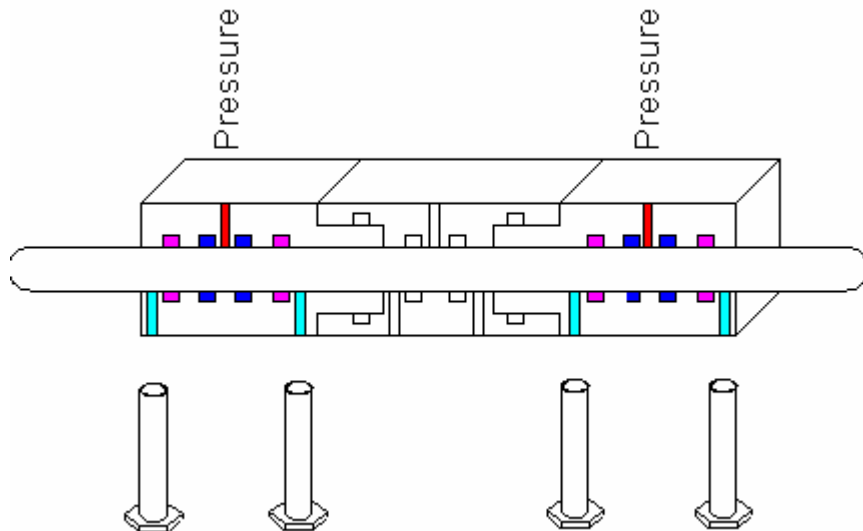
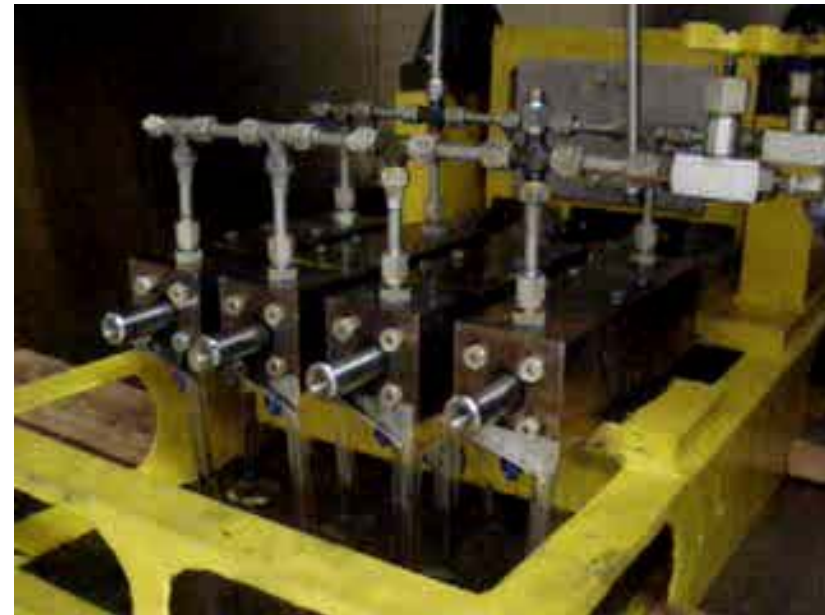
Test Rod and Block/Seal Configuration:

- There are two seal configurations per block and two blocks per rod so that 16 rod/seal configurations are being evaluated per test.
- Primary seals are indicated in blue and the secondary seals in magenta.

- Located at NAVAIR Patuxent River Hydraulic Lab.
- Master hydraulic piston drives four test rods. Each rod passes through two blocks (“Near End Block” and “Far End Block”).
- Apparatus is mounted inside an environmental chamber capable of maintaining a temperature between -65° and +300° F.
- The master piston passes through a sealed port on the environmental chamber.
- The hydraulic power supply is located outside the chamber for increased reliability of the test hardware.
- Hydraulic lines to the fixture are single-ended and thus should not heat or cool the test hardware.

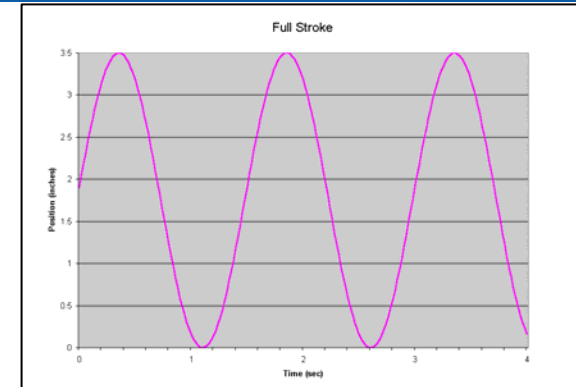
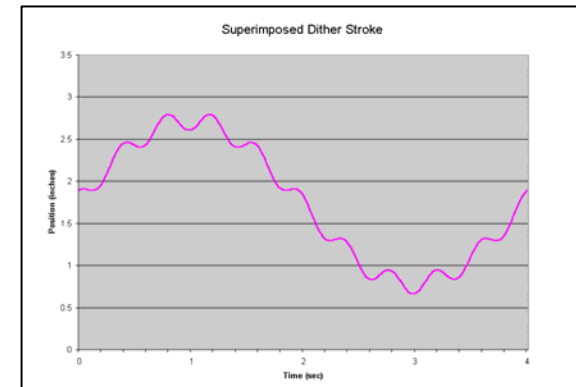
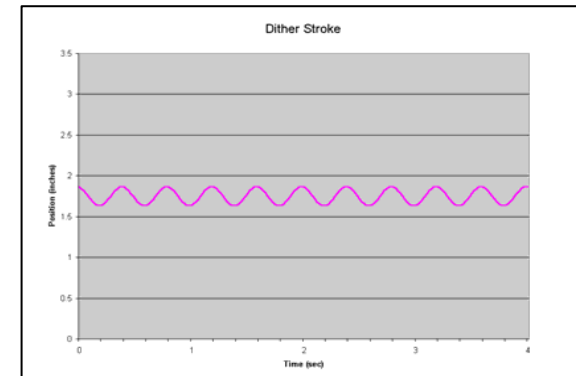
Stroke Profile:

- Full Stroke (3.5" Stroke, 1.5 second Period, 20 Minute Duration per Hour)
- Superimposed Dither (2" Main Stroke, 0.25" Dither stroke, 4 second Period, 4 Hz Frequency, 20 Minute Duration per Hour)
- Dither (0.25" Dither stroke, 4 Hz Frequency, 20 Minute Duration per Hour)

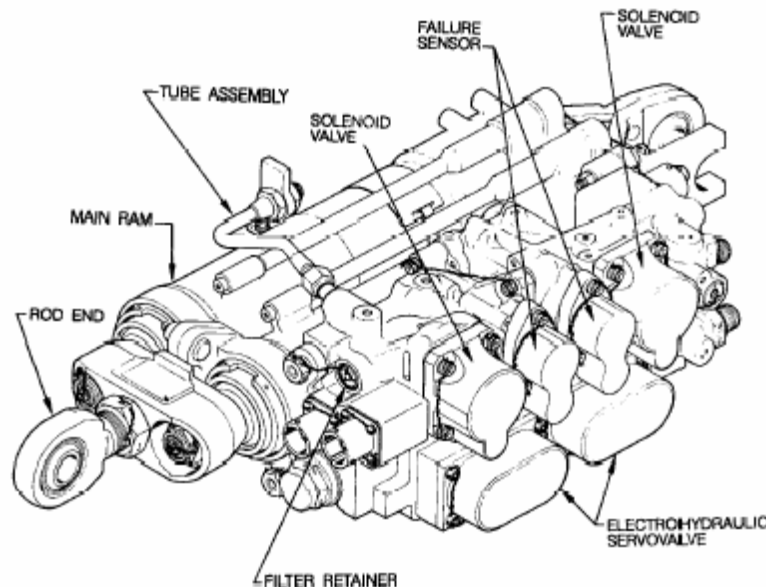
F/A-18 C/D Trailing Edge Flap:

- Same dynamic and static seal materials used for TEF as proven on STAB.
- Side by side design allows one chrome rod and one HVOF rod to evaluate seals against both rod surfaces.
- Endurance testing of TEF has begun and is 2/3 complete. Currently awaiting a different seal configuration to resume the evaluation.
